CASE STUDY: LEONARDO ARMS BUILDING I – BUILDING RESTORATION

Adapted from the Original as Published in the Florida Community Association Journal

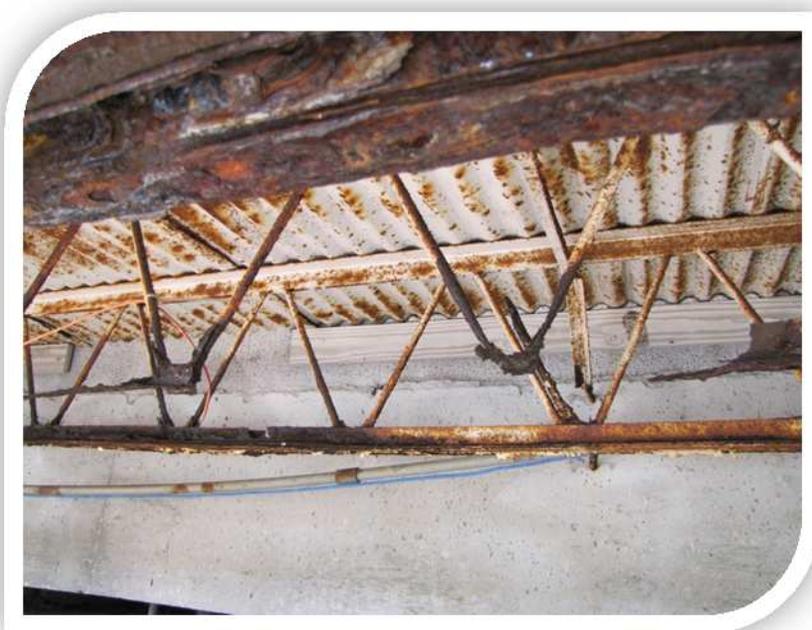
Several months ago, when an association board member and the board president crawled under the first floor walkway of Building One in an effort to resolve an unrelated concern, they were shocked when they looked up and observed extensive damage to the steel joists supporting the walkway. Even as lay persons, they knew enough to be seriously concerned.

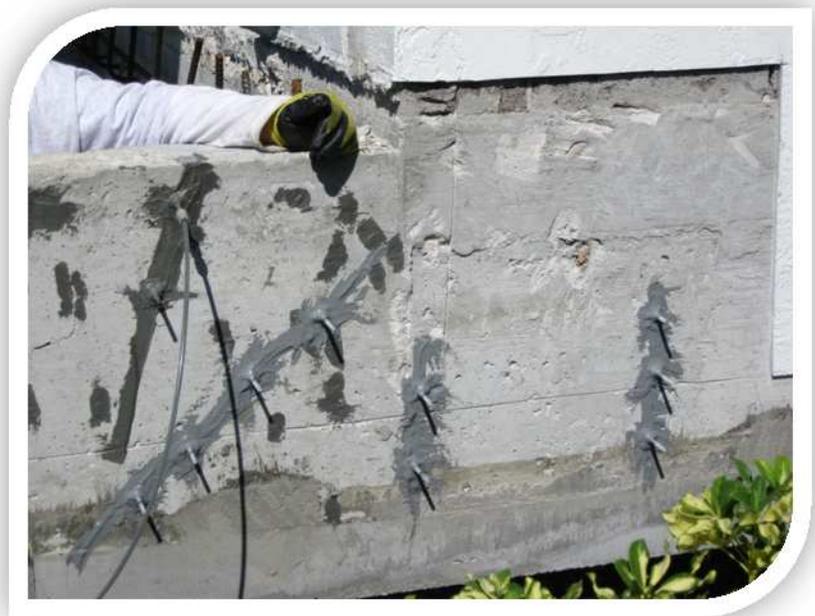
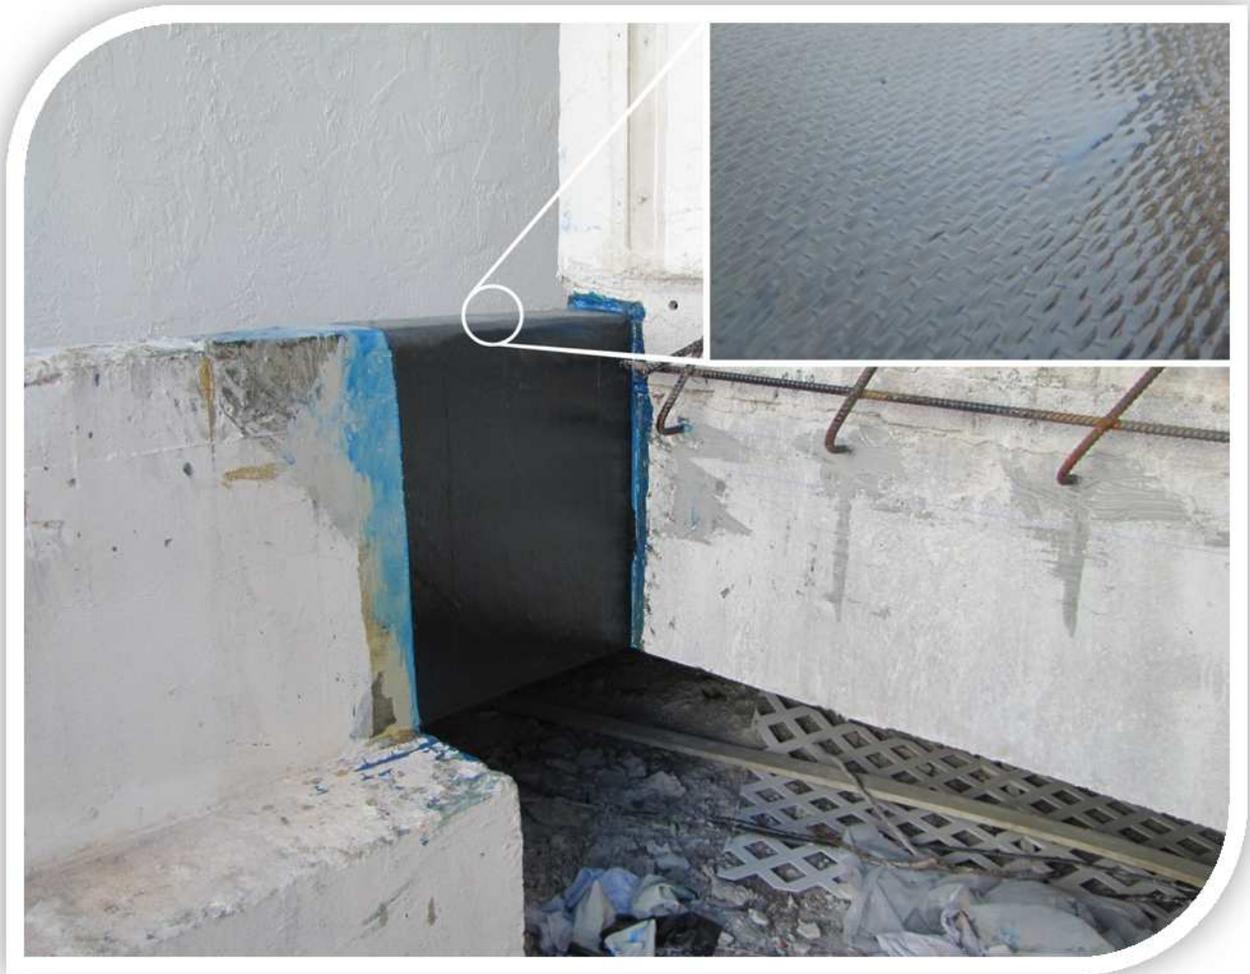
The first concern was a diagonal crack on the grade beam between the corner of the building and the piling cap on the first floor below the now-removed balcony at the southwest corner. The crack appeared to be a shear stress crack usually caused by overloading the end of the reinforced concrete beam. This exact construction configuration was repeated in two other locations beneath other corner balconies, both containing the same shear crack as the first beam. After some analysis, it was determined that the beams were overstressed and required repair and additional strengthening to be retrofitted onto the beams. The overload was caused by either a design defect or construction defect, but in either case was inherent to the original construction of the building.

The first problem could only be resolved by adding shear strength to the affected beams containing shear cracks. But before they can be strengthened, they have to be repaired. Stress cracks are most effectively repaired by injecting them with a low viscosity high strength epoxy.

The process is aptly called “epoxy pressure injection” and will ensure that loads, which were previously circumventing the cracks, will once again pass through the cracked areas as originally intended. The cracks are sealed except for occasional ports that allow the epoxy to be injected under pressure into the cracks. The epoxy will fill the voids created by the cracks and should be visible in the adjacent ports as it fills.

The chosen method used to strengthen the beams was a carbon fiber wrap system fully bonded to the beams and bridged over the shear cracks. The completed wraps will add the necessary strength to ensure the beams can handle the loads they were originally intended to carry.

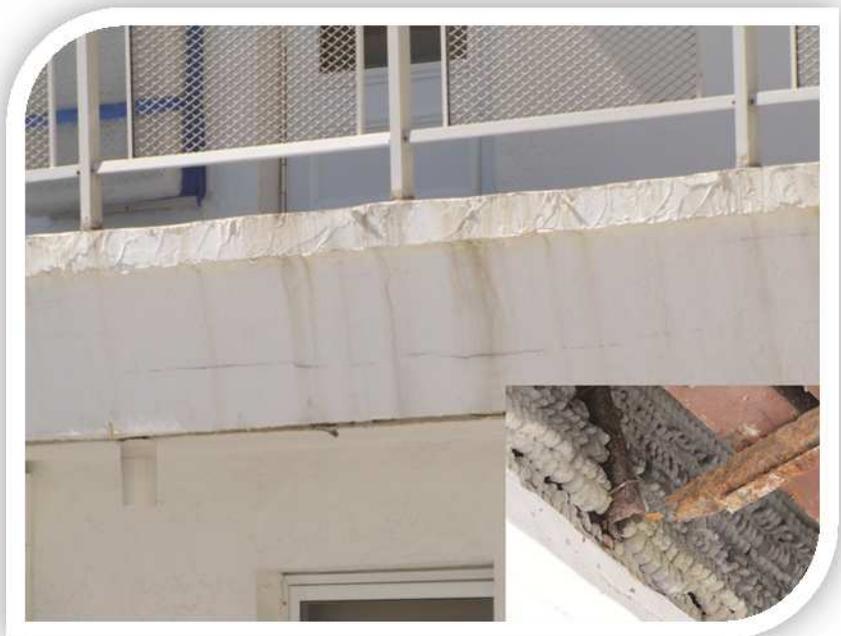
The Leonardo Arms Building One Association planned ahead and prepared a contingency amount of funds for such overages. The scope and cost of the overages was agreed upon and the project never missed a beat. The suspended stucco ceiling above the walkways was previously repaired incorrectly. Almost all areas that were repaired during the previous restoration project needed replaced and were removed. The metal framing supporting the stucco lath (metal mesh which the stucco is placed onto) was installed per industry standard details. Many details and specifications that are "standard" in new construction have flaws that are exposed only after a building has significantly aged. This was the case with the stucco ceilings. When exposed to only a small amount of moisture the framing would rust and break apart. In many locations, hundreds of pounds of stucco were suspended above the walkways and residents' heads by caulking and paint alone.

The Engineer and Contractor met to discuss a new framing method and develop a system that went beyond the "industry standard". The final design changed the original system and included rust resistant materials and redundant fastening so that if the damage ever occurred again it would reveal itself and not fall.

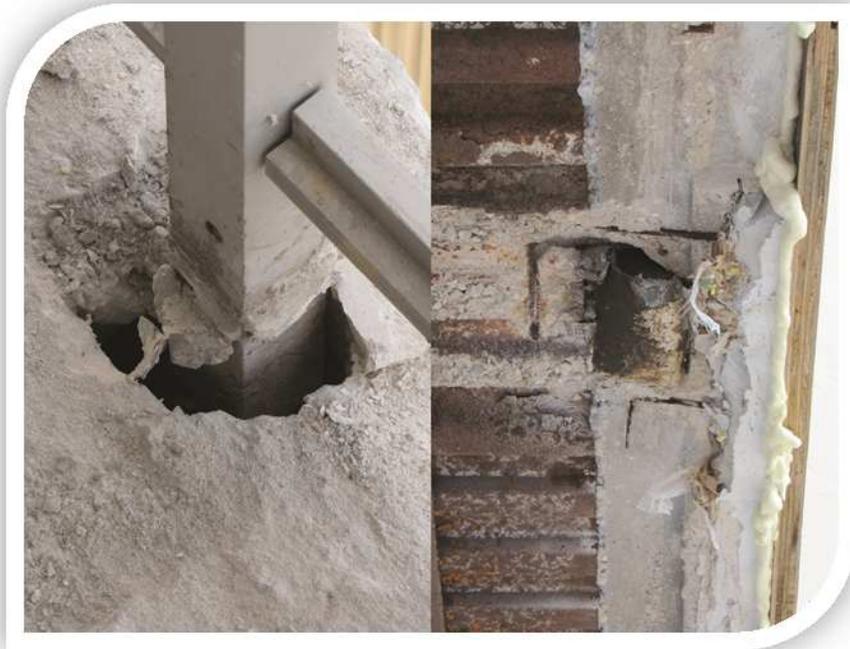
The next challenge was installing the new guardrails. The original guardrails were core drilled and grout set into the slab. When the contractor started removing some of the rail posts he discovered several issues. First, the slab was barely 3" thick at the edge and there was no metal pan for the last several inches. This meant, if new holes were to be cored into the slab the contractor would likely punch through the slab and there would be no way to pack the grout in around the new posts since it would all just fall into the ceiling below. The second problem

was that the original construction of the building exhibited this very problem. In many locations, cardboard, roofing felt, and other miscellaneous materials were found in otherwise hollow cores.

It appears that the original contractor wedged whatever he could find into the post pockets in order to temporarily hold them still, then poured his $\frac{3}{4}$ " concrete topping against the rail, locking it into place and hiding the mistake. The association was fortunate over the years that the limitations of the old rail system did not result in the harm of any persons.

A surface mount method was decided upon as the only viable way to safely attach the new rails to the slab without significantly rebuilding all the walkways.
