CASE STUDY: LEONARDO ARMS BUILDING I – BUILDING RESTORATION

Adapted from the Original as Published in the Florida Community Association Journal

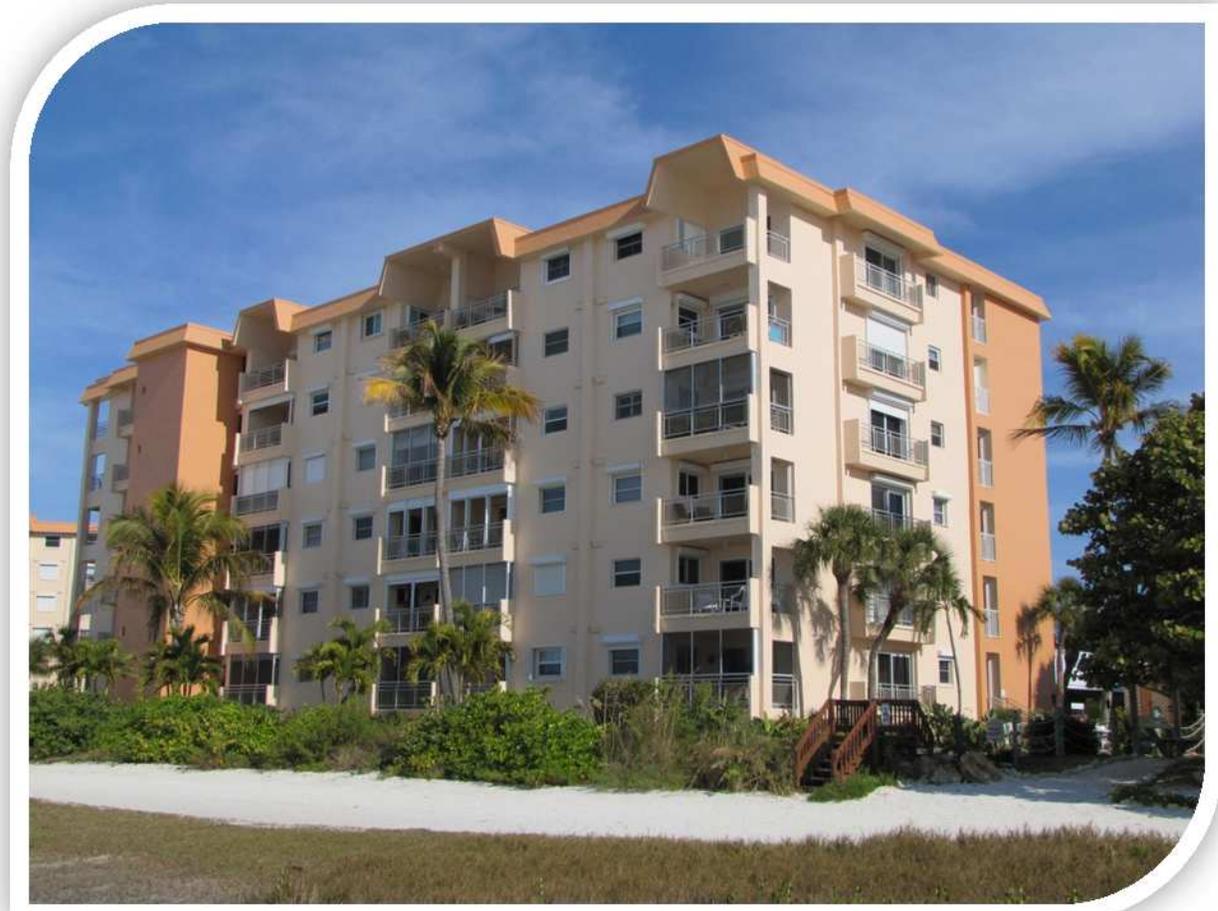
Old wooden walls built alongside the main walkway ramps were also torn down in favor of extending the new guardrail and adding additional awning material. The overall change took the building from a drab 1970's appearance to a vibrant and warm place to call "home". To say the residents at Leonardo Arms Building One were happy about the final results would be an understatement.
